ST TERESA'S [HOUSE] AND CURTILAGE

FORMERLY "CRAIGMORE"

ARCHITECTURAL HERITAGE IMPACT ASSESSMENT AND
CONSERVATION METHOD STATEMENT

SHD PLANNING APPLICATION DOCUMENTS

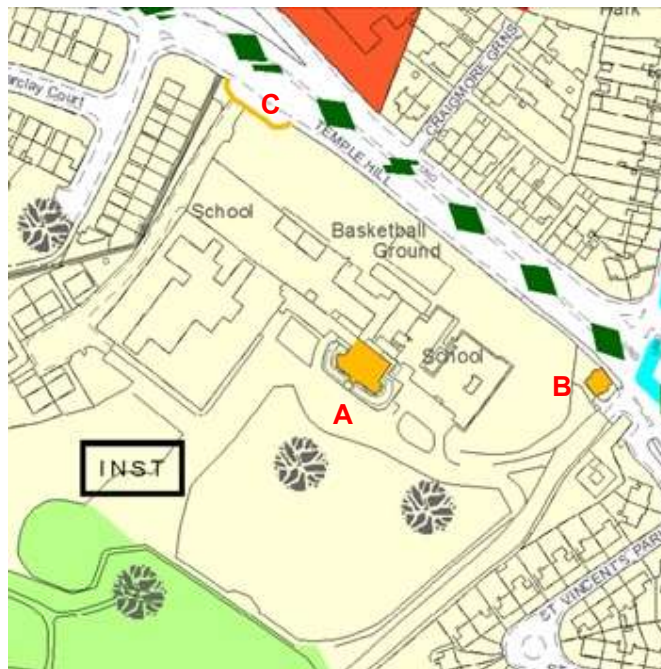
**Dun Laoghaire Rathdown Development Plan Protected Structures coloured Orange
A: House (centre); B: Lodge (right); C: Gateway (top)**

The site's buildings include three Protected Structures (main house, lodge and gateway) and these were, until recently, in the same ownership as the adjoining house known as St Catherine's. The two houses, St Teresa's and St Catherine's, were themselves built on the original curtilage of an earlier house, Rockfield, and were first known as Craigmore and Dunardagh respectively.

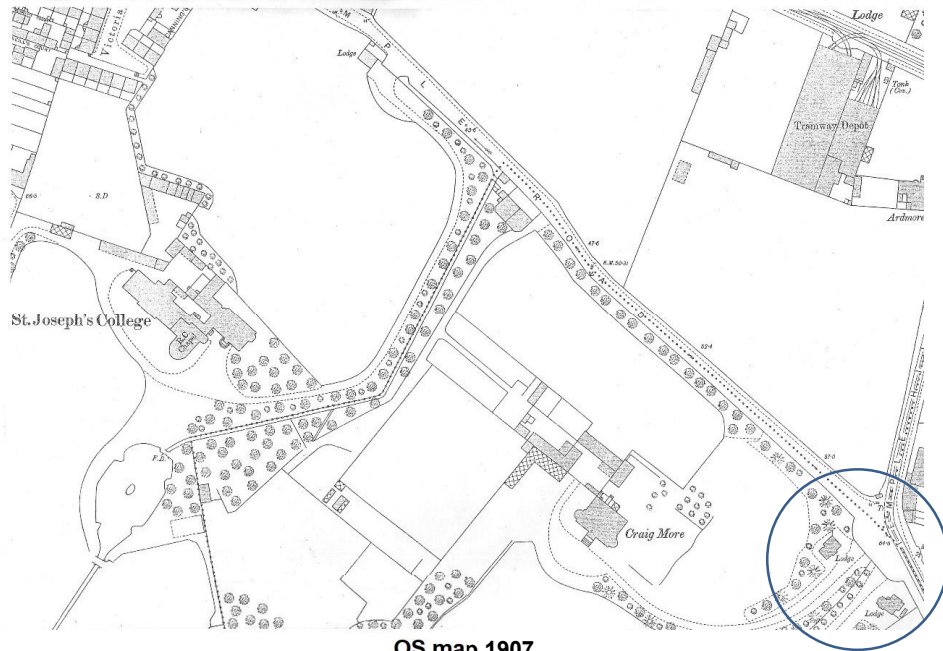
OS map 1907

Note gates and double avenue at eastern corner

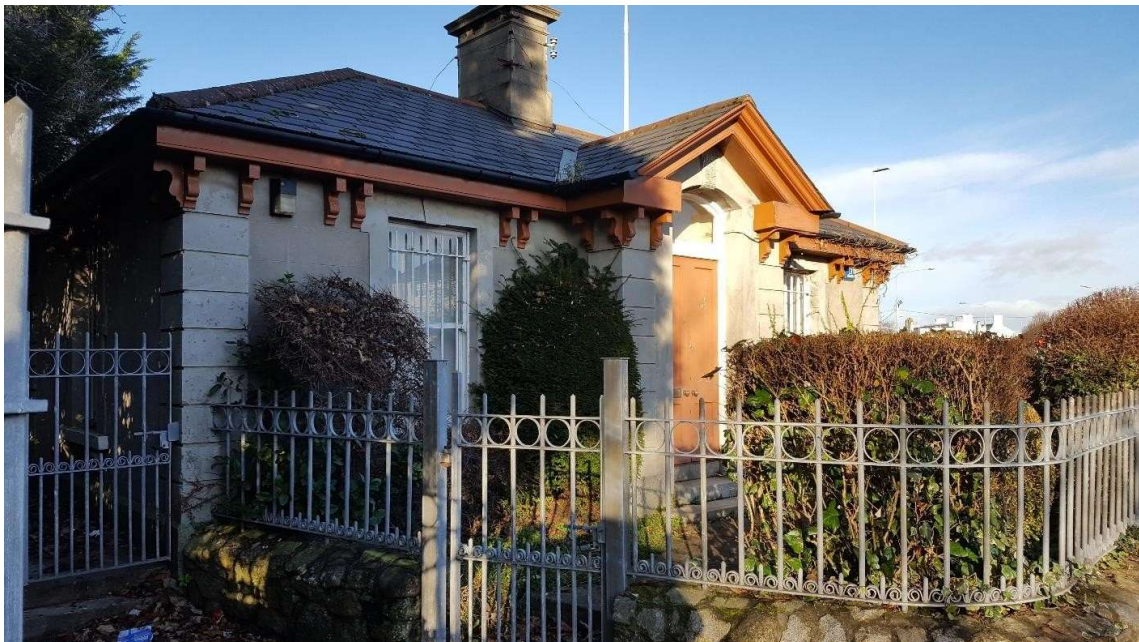
Gate-lodge with new (1980s) boundary treatment.

The c.1866 gate-lodge which survives is on the new boundary wall at Temple Hill and has been unoccupied for some years. At the time of its construction, it was part of a composition which included the vast (30m wide) double gateway which served both Craigmores and Dunardagh.

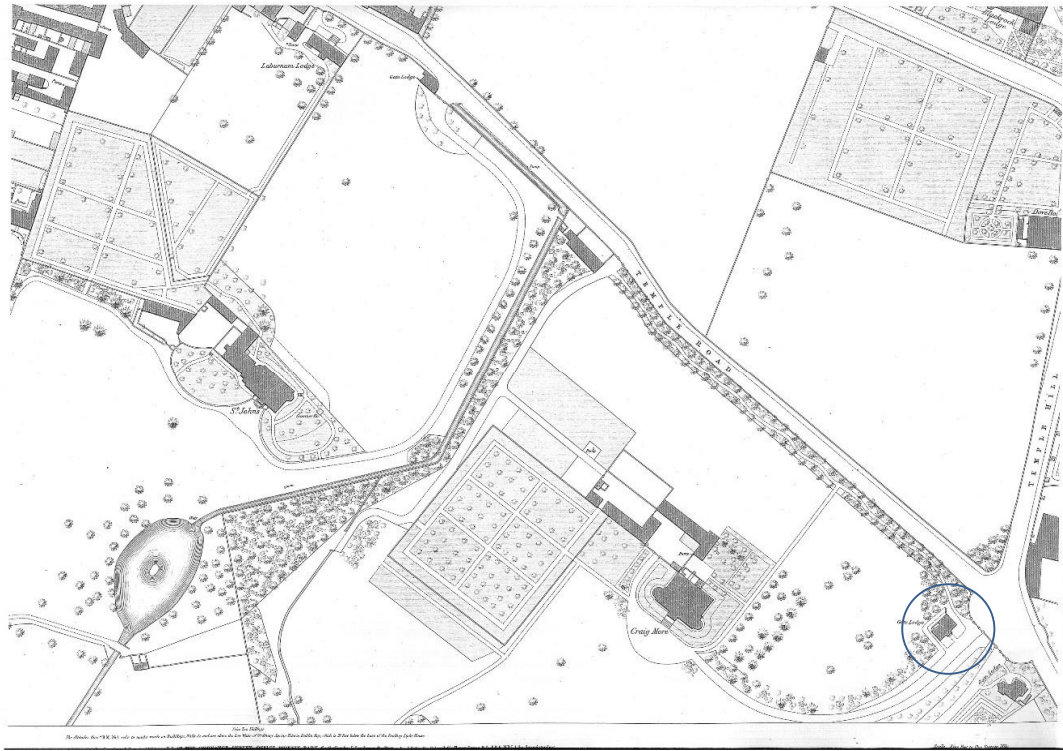
1867 OS Map

Note: lodge now shown as having been built since 1865 map

J.A.K. Dean⁵, describes this lodge as a of a pattern to be found in a number of other locations and suggests that the demolished west lodge was the only approach for more than a decade. However, the 1865 and 1867 maps do not seem to bear this out and it seems unlikely that main entrance was ever at the north corner of the sit. .

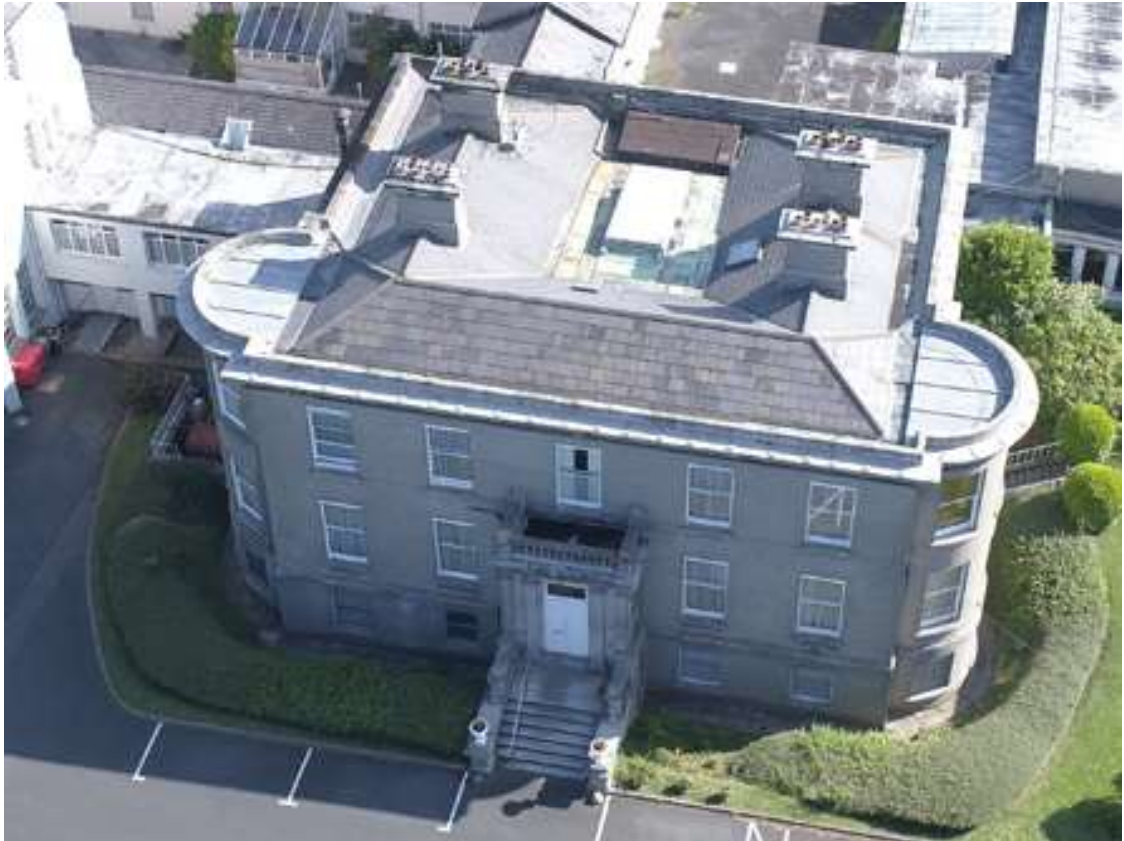
The original roof profiles are in place, these being a U-shaped plan A roof with hipped ends and lead-rolled flat roofs to the bays.

Aerial View of Roof

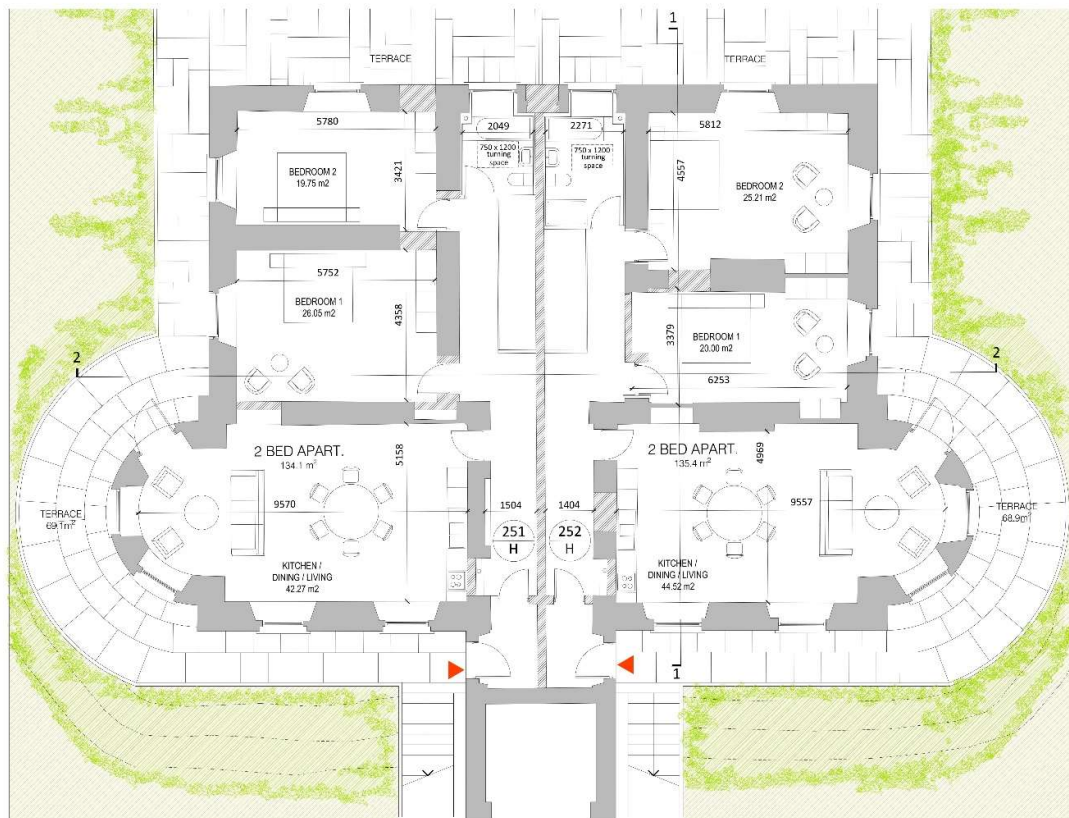
St Teresa's House Proposed Lower Ground Floor Plan

Previously blocked up windows to the bay windows on either side will be reopened and provided with sliding sash windows in timber to match the originals. The doors to the middle room of either side will be blocked up to cill level and new windows and cills inserted. As these are now to be bedrooms, direct access to the outside is not required nor desirable. Instead, the northern windows in each bay window will be converted to doors. The leaves will have glazed panels to the same design as the adjacent windows with solid timber lower halves. This is a common 19th century device.

The plasterboard ceiling to the entire lower ground floor will be removed to permit the installation of M & E services in the hall floor void, and then replaced with fire and sound resisting construction.

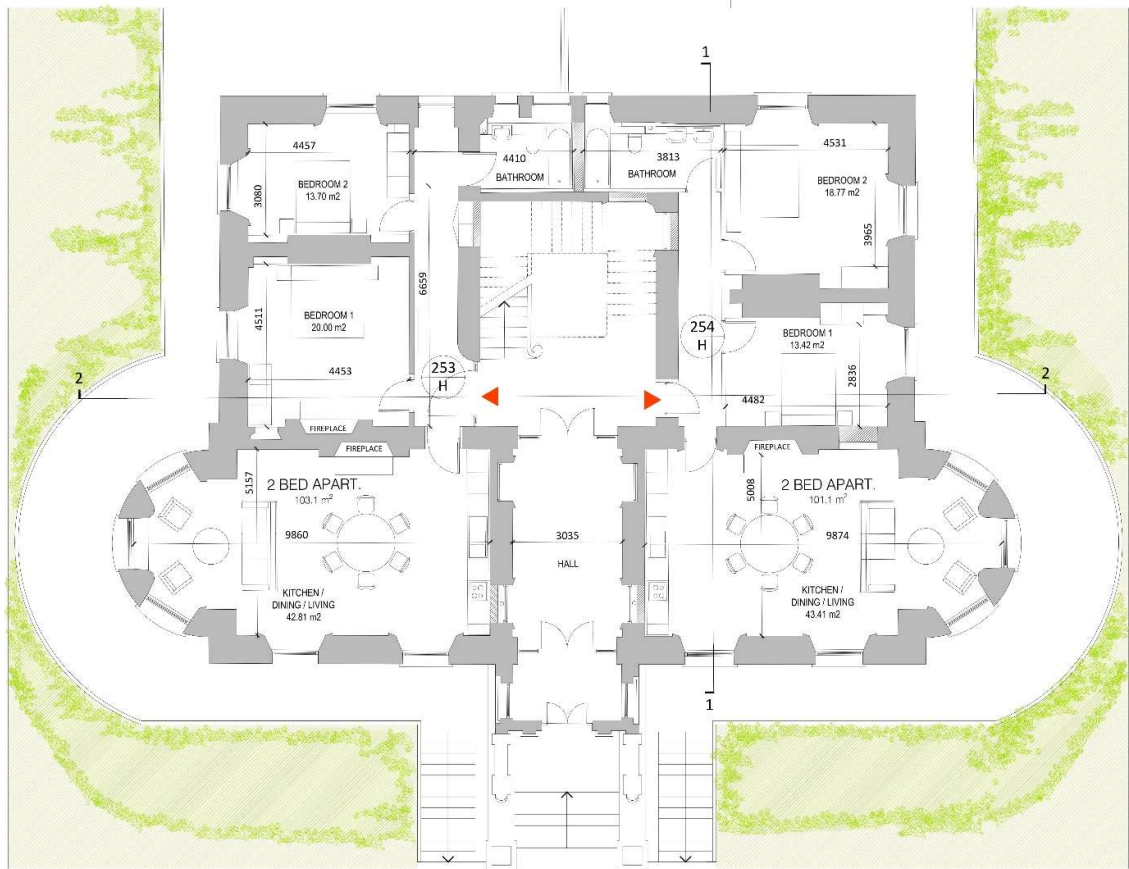
St Teresa's House Proposed Upper Ground Floor Plan

Generally, the treatment for this apartment will be the same as for H3. However, the hall/corridor parallel to the main, common, hall will be newly inserted with an opening formed between the middle and rear rooms on this side.

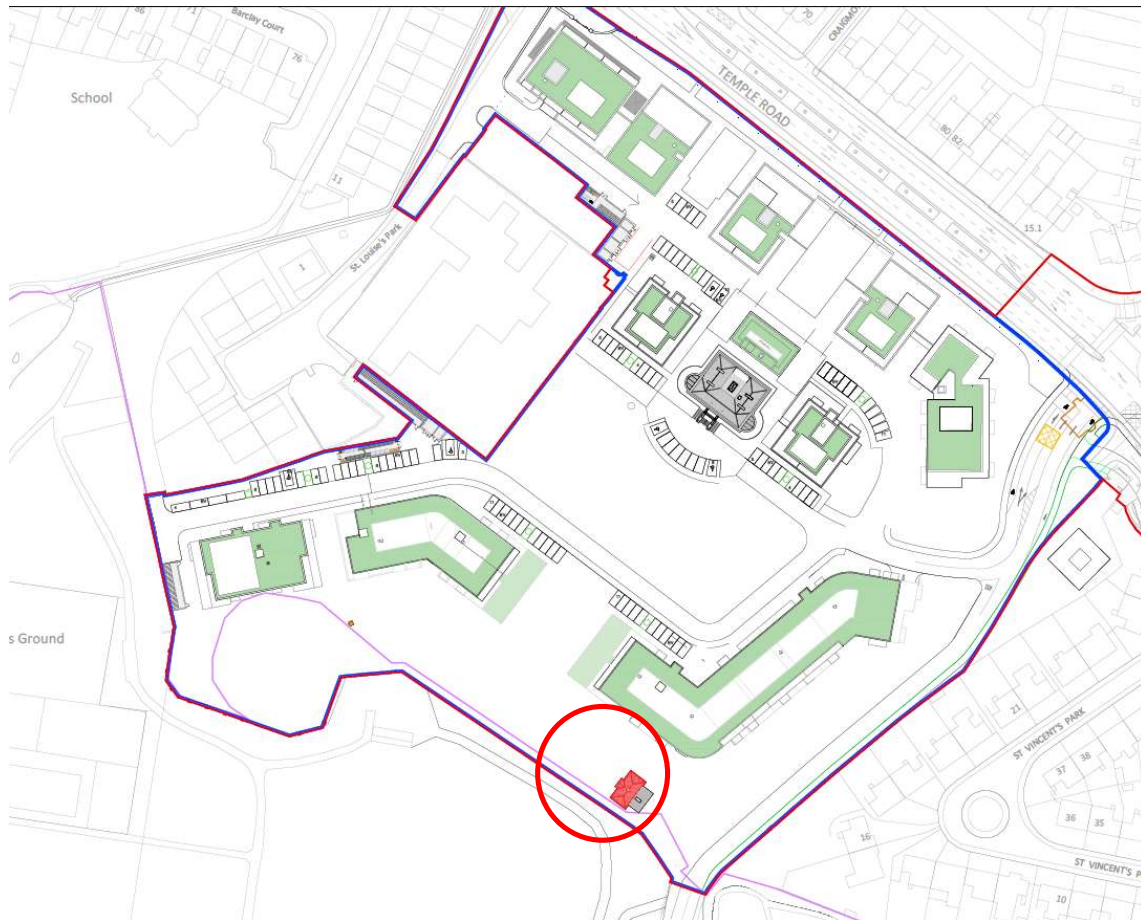
Site Plan 2021

The proposed location of the reconstructed gate lodge is shown below.

The proposal in relation to the gate-lodge is to move or relocate the structure and to reconstruct it in another position related to St Teresa's house. Demolition, which the Act only permits in exceptional circumstances, means the complete destruction of a structure and the total loss of its fabric, without possibility of repair. The proposal here is to carefully dismantle the structure and to re-use almost all those elements of its fabric

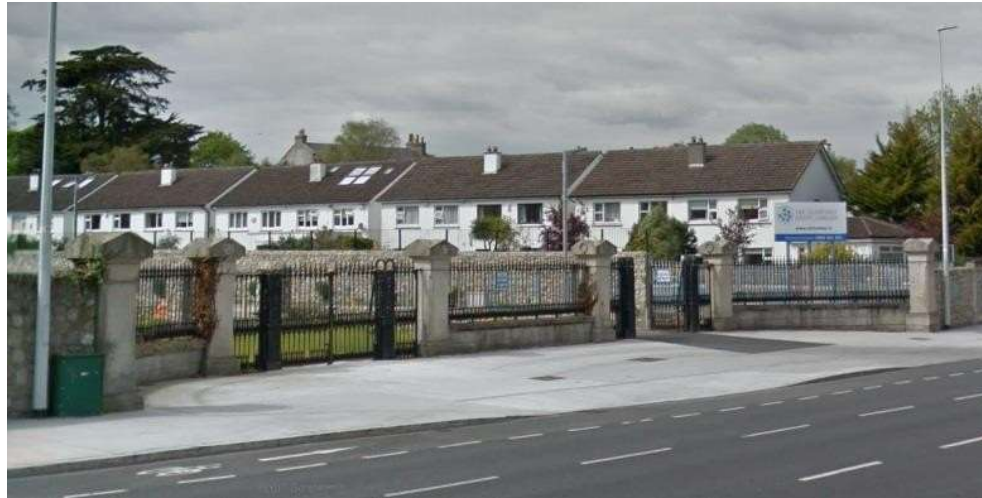
Original 30m wide gateway in new (1988) position

Since the completion of the Blackrock town bypass in 1988, this visual relationship has been destroyed. The centrepiece of the composition, the gateway, has been removed and reassembled at another location at the north-western corner of the site and the opposite gate-lodge and parallel avenue have been removed. Furthermore, the boundary of the site has been moved southwards, so that instead of the lodge being located some meters inside the boundary walls, as was traditional, the building now sits awkwardly on top of an inappropriately detailed new boundary wall. A poorly designed lean-to extension has been constructed to www.oneillarch.ie

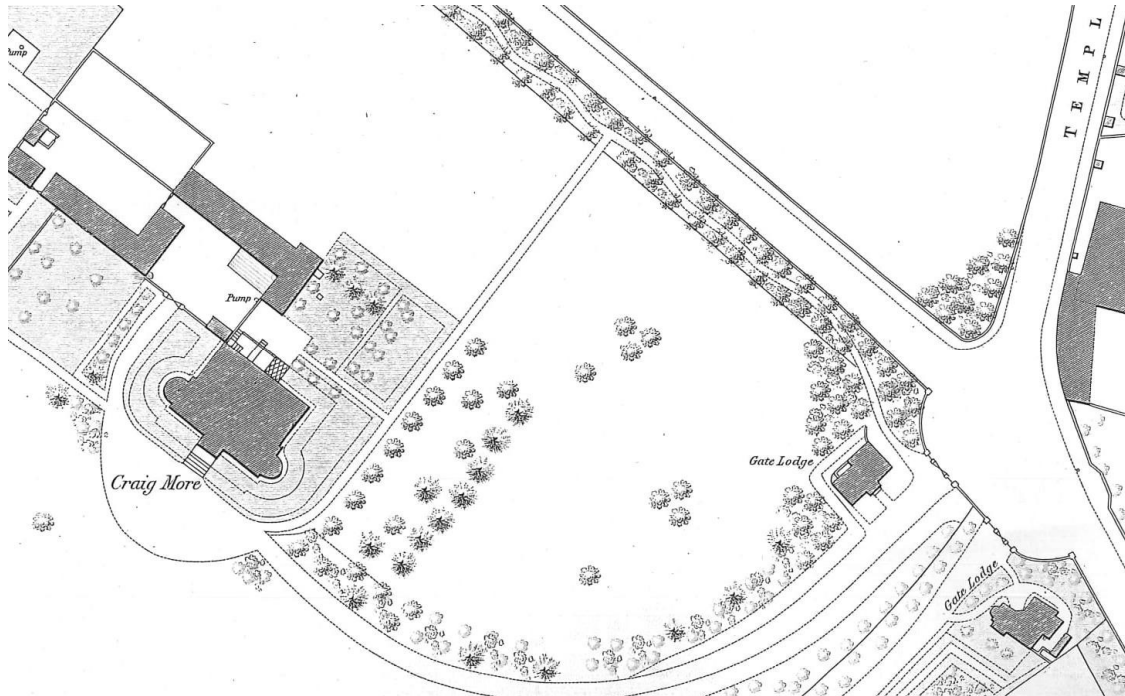
**1867 O. S. Map
showing 30m wide gateway, double avenue and two gate-lodges**

The structure is in its original location, as is its parent structure, and a link does therefore remain. However, the context of this location has changed irreversibly. The gatehouse was originally (c.1867) located some meters inside a very wide (30m/100 ft) entrance gateway having two pairs of gates and a double driveway or avenue, with a second lodge serving another house located on the opposite side of the double avenue. The gate lodge was conceived as a composition of three distinct structures each having a particular relationship with the boundary and public road and with each other. That context has now been lost, largely due to the construction of the Blackrock Bypass in the late 1980s and the link to the location much weakened as a result.

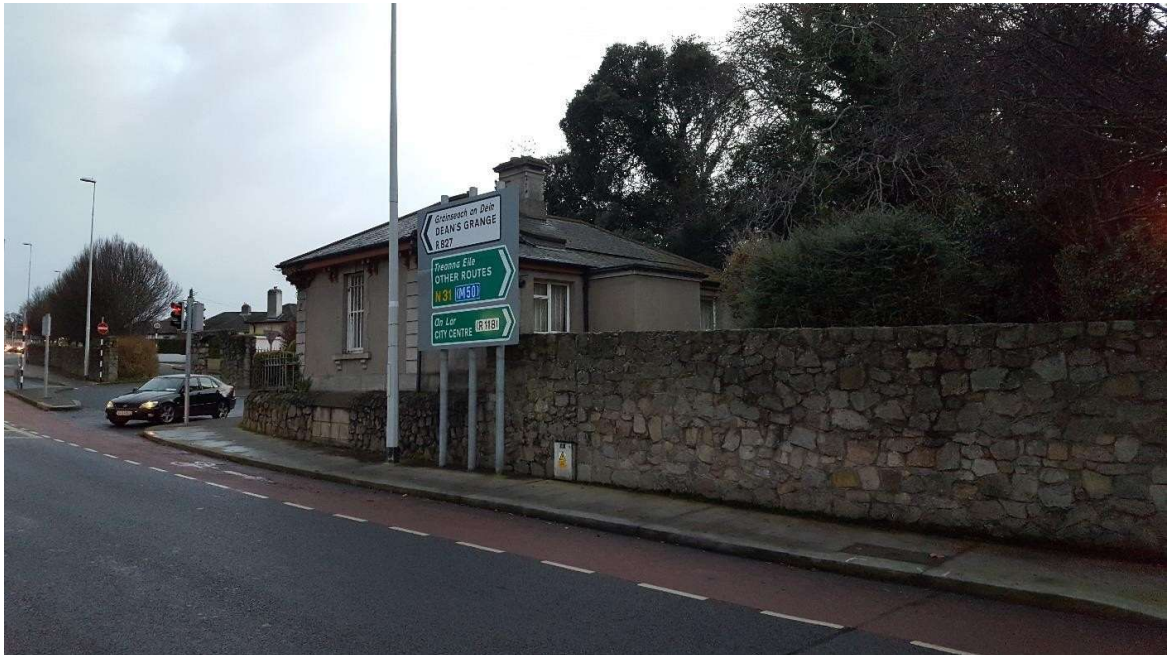
Lodge and lean-to and new boundary wall in un-coursed rubble

the rear. The slates are now of artificial material and the rainwater goods of plastic. A galvanised steel railing has been installed close to the entrance door in a position where no such boundary previously existed. A pastiche 19th century gateway was constructed some distance behind the lodge, bearing no particular relationship to it and further detracting from its setting.

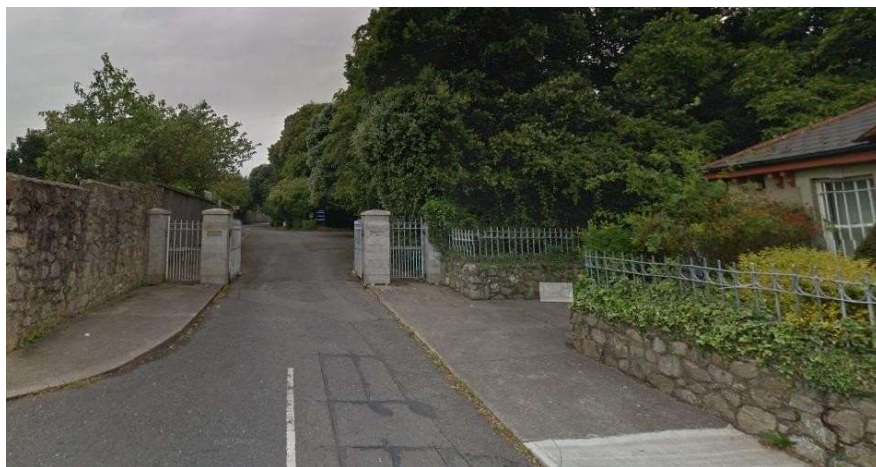
Lodge and 1988 gateway

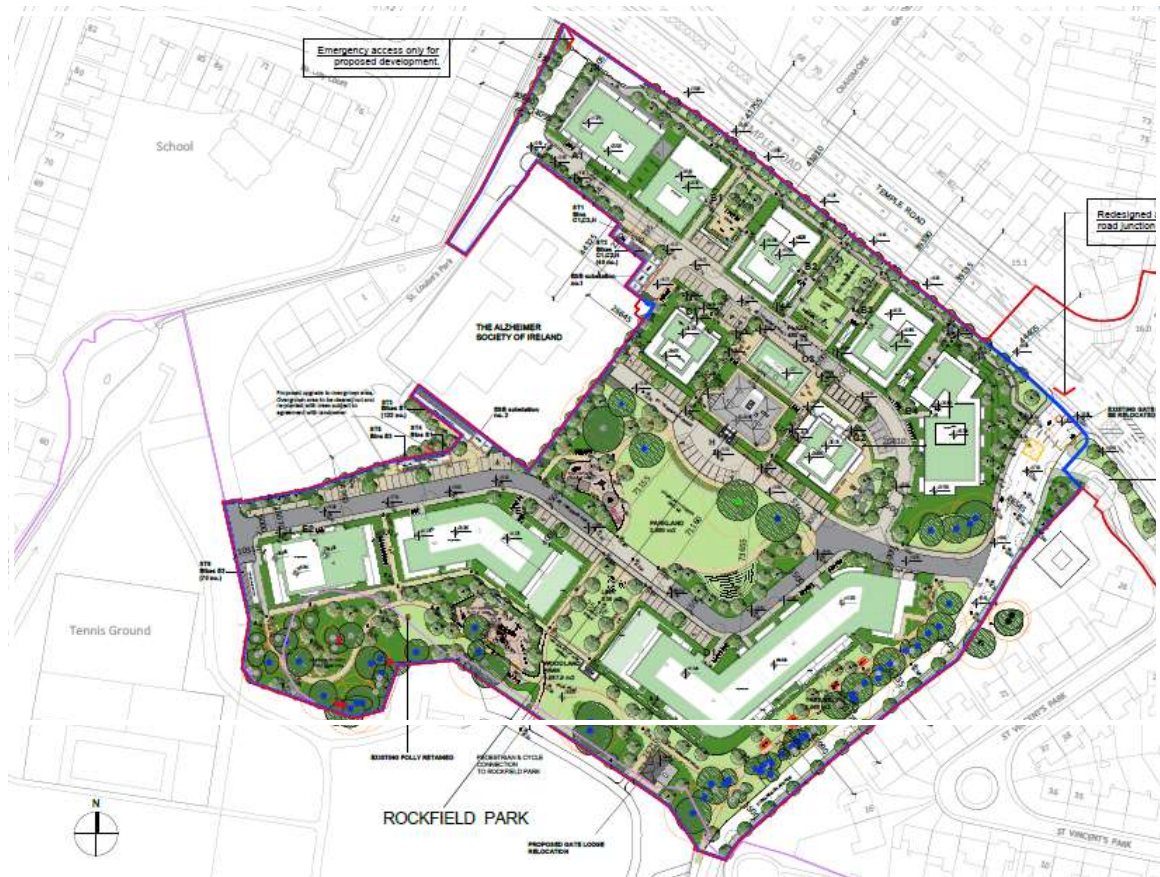
Site Plan 2021
O'Mahony Pike Architects

The current design (above) responds to consultations and workshops with the Planning Authority professional staff and within the design team. Block C3, which houses the residents' amenity facilities, forms a new north-eastern elevation to replace the existing, unsightly, jumble of forms, and will provide a new enhanced relationship with Temple Hill and the proposed entrance plaza, forming a new focal point for the house. Although not abutting the house, it is, in effect, an extension to it, and uses light and complementary materials. Legibility is enhanced through the provision of a generous 5.2m metre separation distance which also affords "breathing space" to the rear elevation.

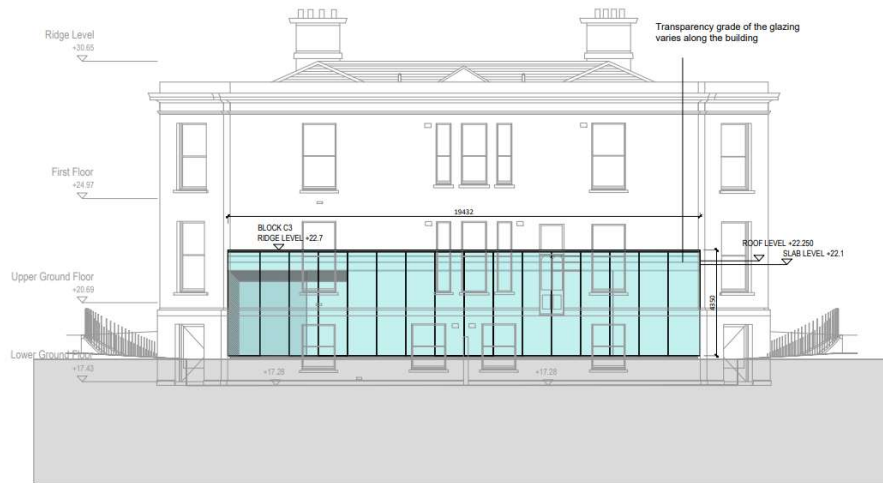
NORTH ELEVATION + BLOCK H

St Teresa's House and Block C3 – OMP Architects Not to Scale

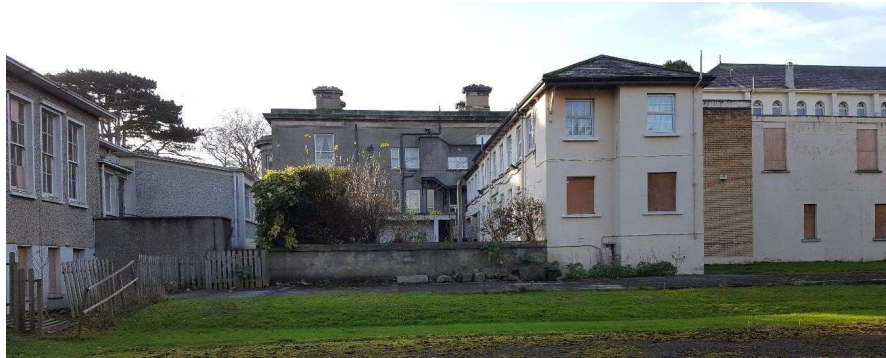
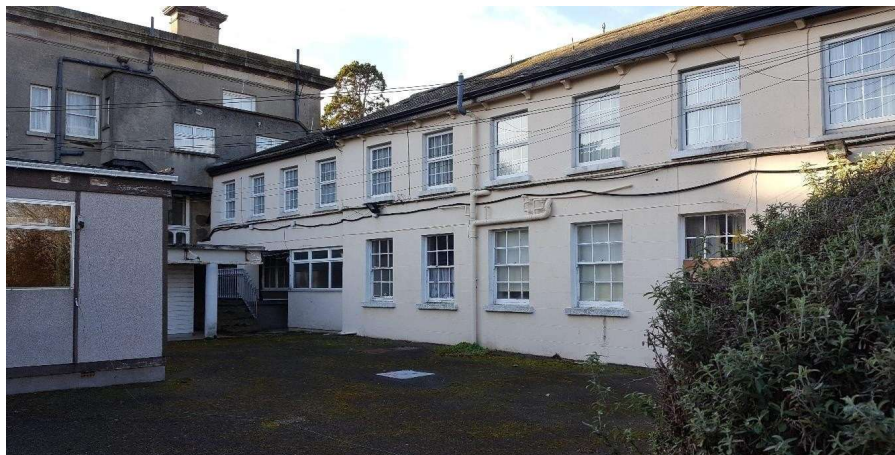
Rear of Building and Stables

As is evident from the photographs below, the rear elevation of the house was not designed to be viewed, especially from afar, and had outbuildings and stables obscuring it from the time of its original construction. Further accretions, in the form of the high-level and low-level link blocks, the open-sided shelter, the 1946 school and the 1962 building further detracted from the appearance. The stripping away of these additions and their replacement with a well-designed subordinate building, will greatly enhance the current setting.

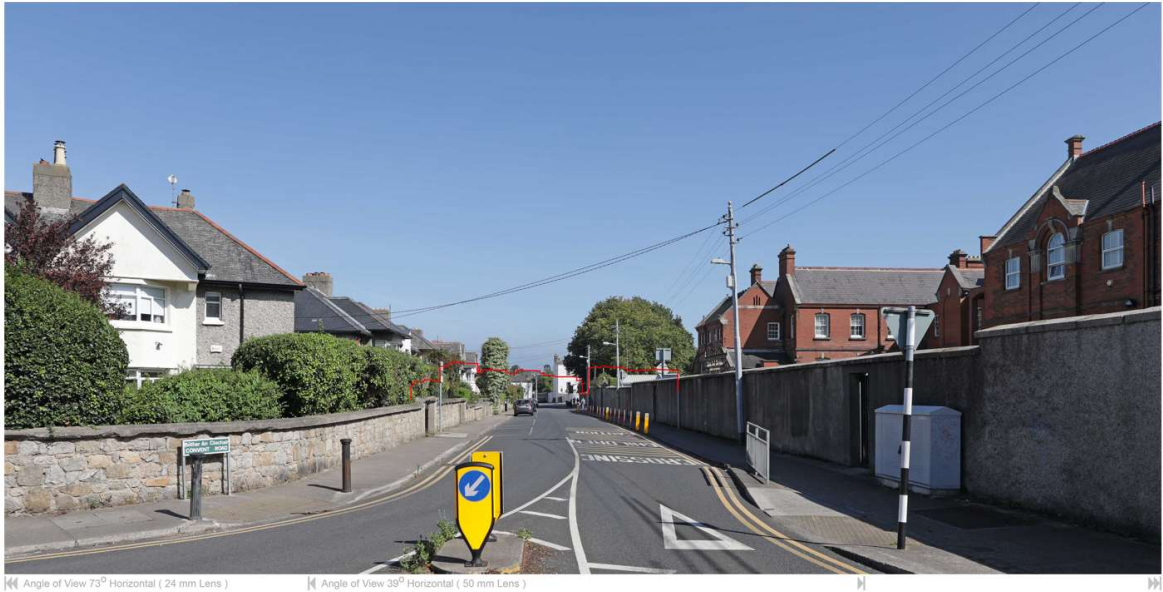
View H

In the Western sector, a representative viewpoint is H, below, taken from the western end of Convent Road, off Carysfort Avenue.

This viewpoint, with the proposed development outlined in red, shows that the visual impact of the development will be slight, and thus its effect on the setting of the Protected Structures on Carysfort Avenue, notably those Prince Edward Terraces, Upper and Lower. There will be views of the development from the upper floors of these houses, but they will be distant at over 400m and seen over the roof tops of four rows of terraces houses and an apartment development

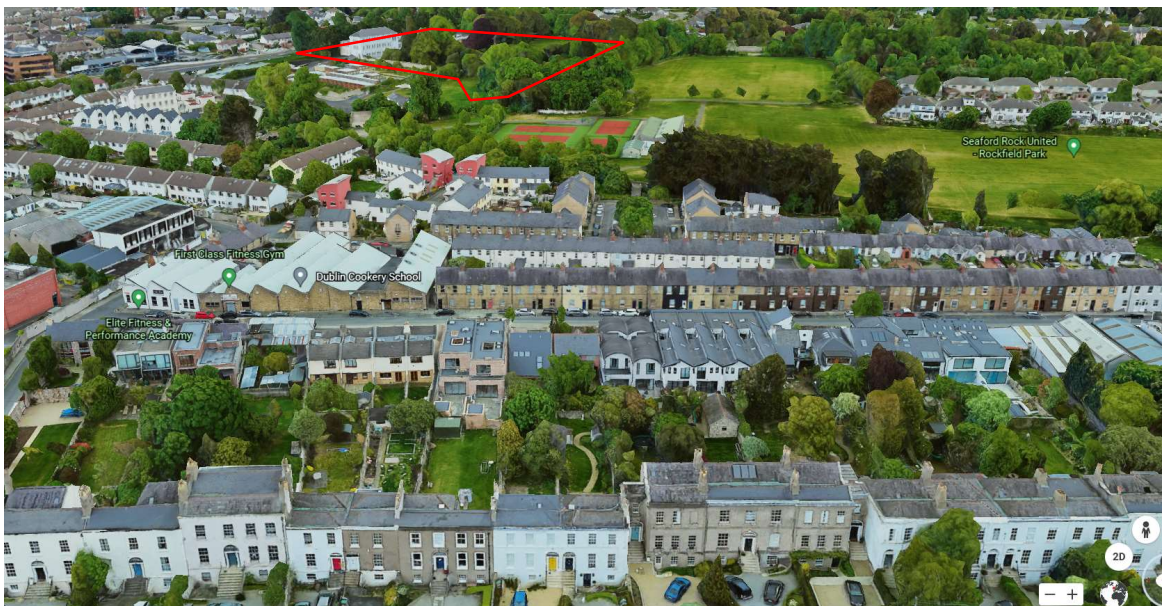
**View westwards over Prince Edward Terrace (foreground) towards site (outlined – approximately)
(Google Earth 9.11.2021)**

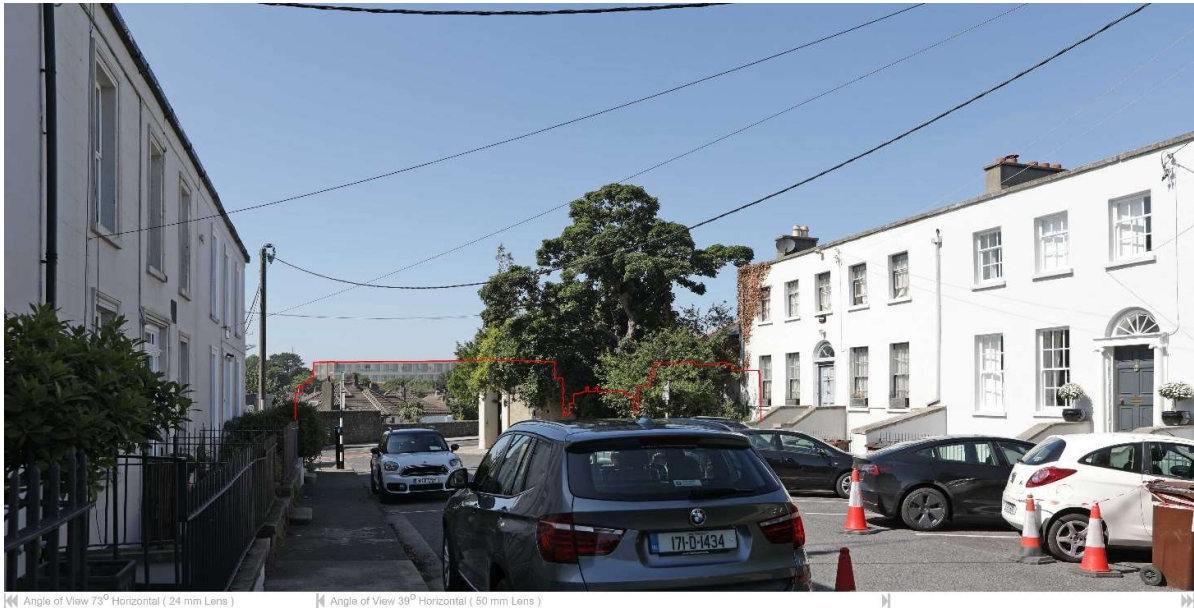
In relation to Montpelier Place, we submit that the alteration to the view is “not significant” and that therefore no adverse effect will be caused to the setting of these buildings.

In the Eastern sector, the two most important views are from Montpelier Parade and Neptune House, an Architectural Conservation Area and protected Structure respectively.

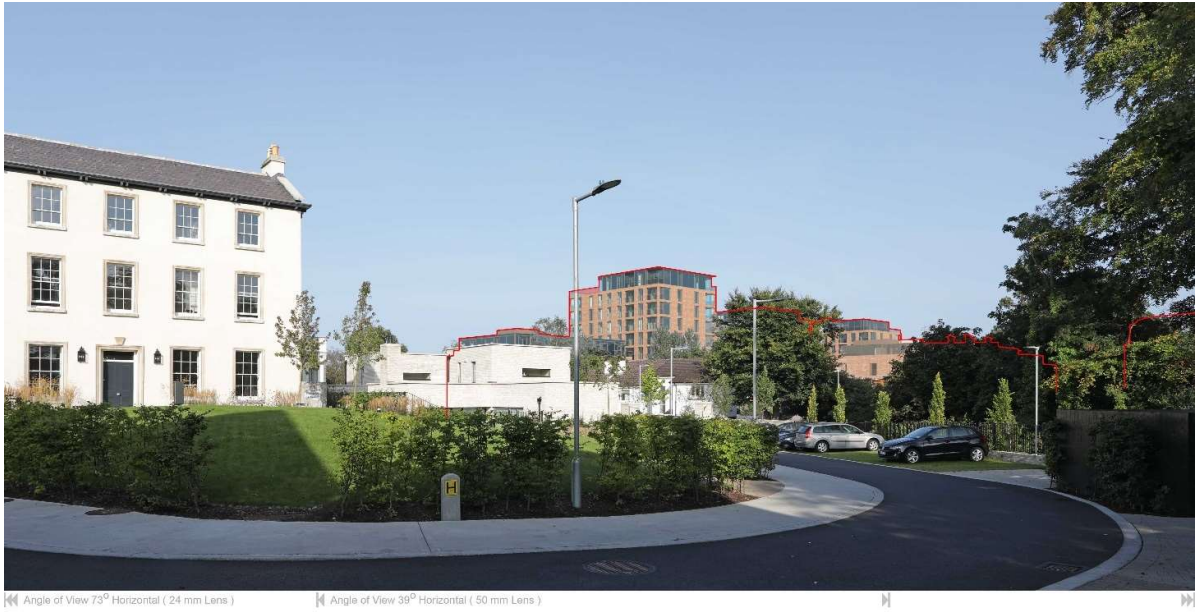
viewpoint: **View I** Proposed
issued: 03-09-2021

At Neptune House, a large detached 19th century house, not unlike St Teresa's., the effect of the proposed development on the setting will be significant, as seen from some angles. We assess this effect as not being adverse and note the already significant changes to its setting brought about by recent development within its curtilage

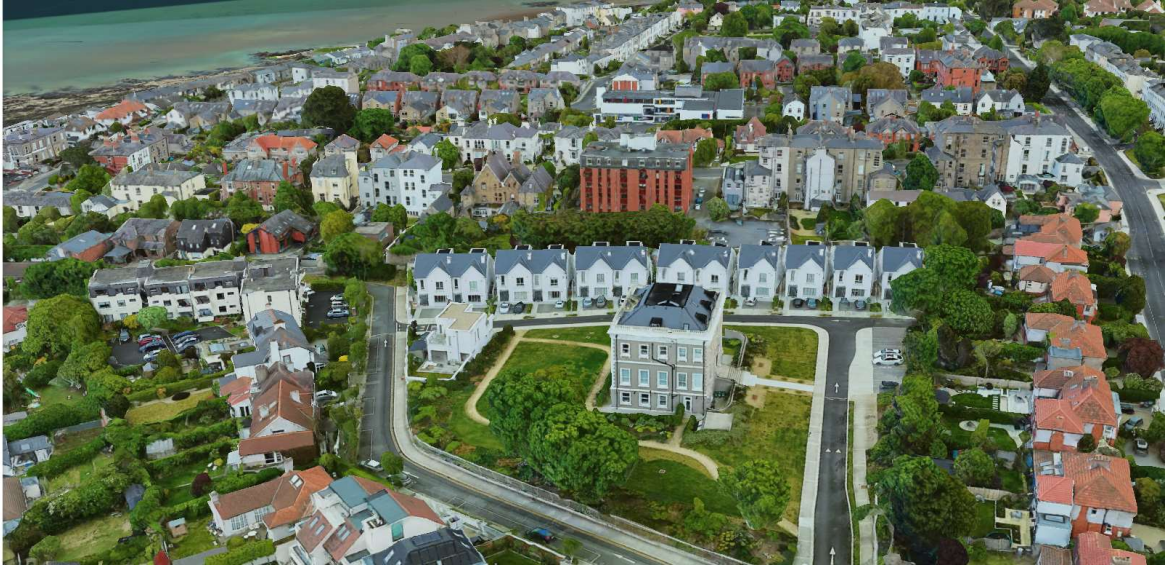
**Neptune House (centre) and recent development within curtilage
(Google Earth 9.11.21)**

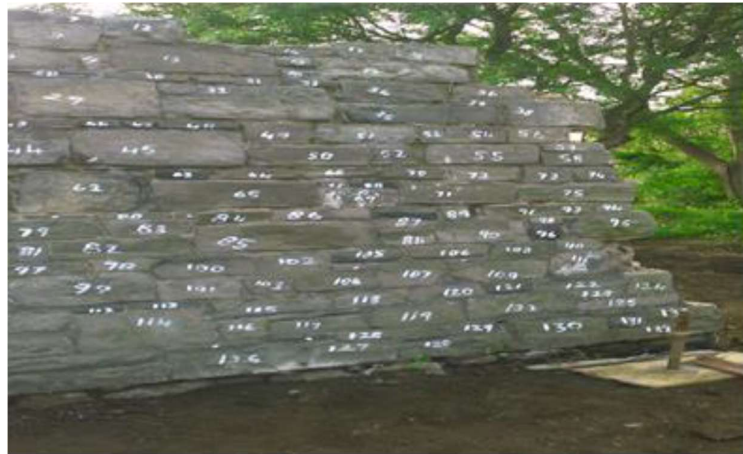
Each individual stone is to be numbered and labelled in preparation for dismantling. See Figure 1

**Recording prior to deconstruction.
Photo courtesy of Nolan Conservation**

Prior to any works being undertaken a detailed map and numbering system shall be implemented so that the wall can be reconstructed to its original detail.

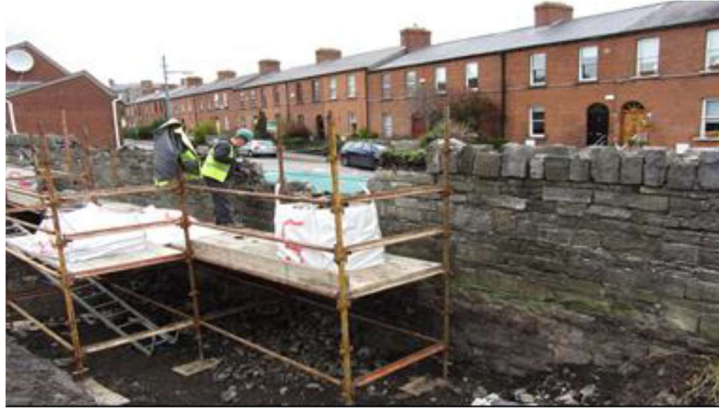
Rebuilding of wall
Photo courtesy of Nolan Conservation

The walls will be reconstructed in rises of 600mm working cyclically around the building, using the material from the appropriate section of the dismantled structure. Completed work may have to be left for several days to allow for carbonation

The main contractor, under the supervision of the Conservation Architect, will set out the building and construct the foundations and rising walls and all below-ground drainage. When the wall is at d.p.c level, the main contractor shall pour the floor slab on insulation on radon and damp-proof membranes and lay a damp-proof course.
